Failure and damage determination of building roofs

Manuel J. Carretero-Ayuso (Main Author)

Manuscript Code: 764

DOI: 10.7764/RDLC.16.1.145

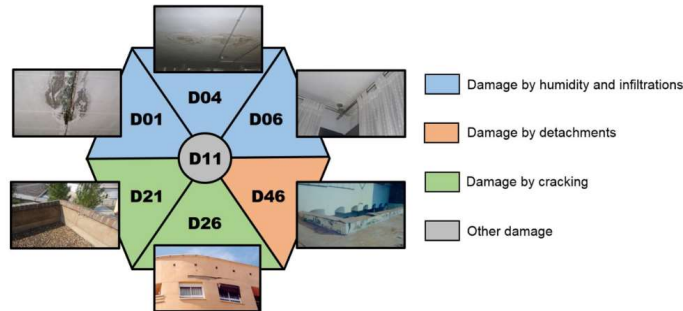
Figure 1. Graphical examples of the types of damage groups by similar anomalies. Source: images by Manuel J. Carretero-Ayuso.

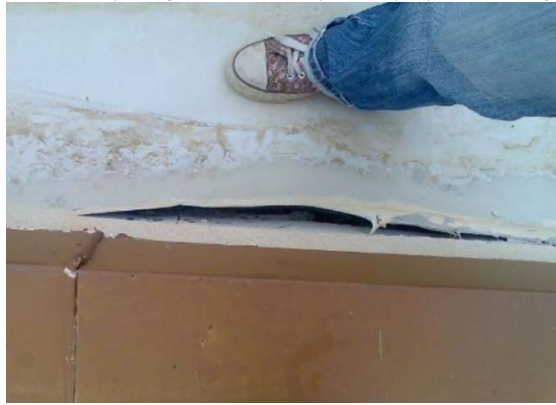
Figure 2. Deficient tail-end between the waterproofing membrane and the perimeter parapet. Source: image by Manuel J. Carretero-Ayuso.
